Manhole Inspection Summary

Manhole # S19KK_007MH

Insp Date: **6/1/07 11:48 AM**

Location Address: **2100 CLIFTON AVE**

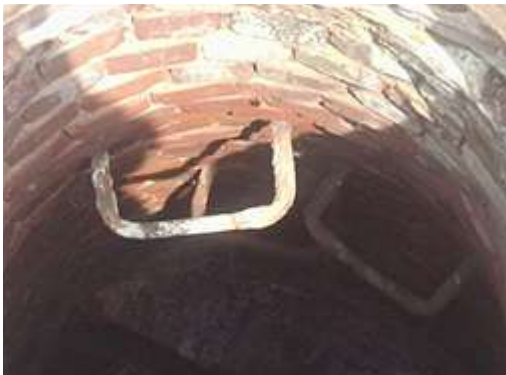
Defect 2

Steps Count: **5** Missing: **0** ☒ **Corroded**

CORRODED STEPS

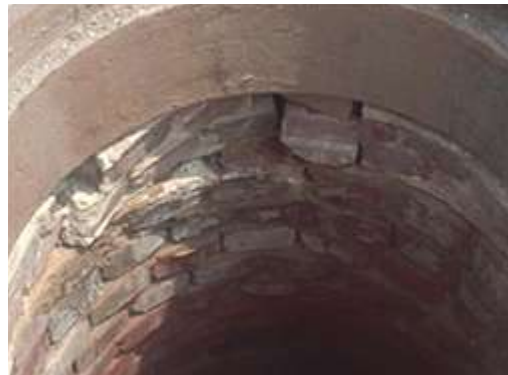
Defect 1

Condition: ☐ Sound ☒ **Cracked** ☐ Root Intrusion ☐ Loose Brick ☐ Deteriorated

CRACKED CHIMNEY AND CORBEL

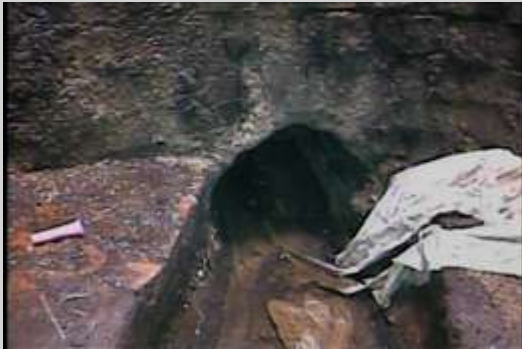
12 O'Clock Outflow

12 in. Circular Gravity Sewer
Pipe Out @ 12 O'Clock

Pipe Height: **12** (in.) Rod and Bar (Angled)
Pipe Material: **Clay** ☐ Pipe Lined
Invert Depth: **10.51** (ft.) Flow Characteristics: **Slow**
Deposits: ☐ None ☐ Mud ☐ Sludge ☒ Debris ☐ Grease
Silt Depth: **2** (in.) Deposits Extent: **Light**
Infiltration: **None** Pipe Seal Cond: **Sound**

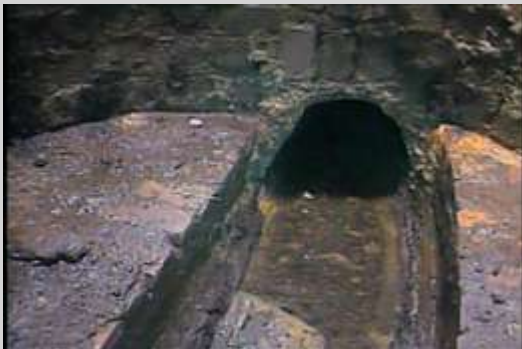
6 O'Clock Inflow

12 in. Circular Gravity Sewer
Pipe In @ 6 O'Clock

Pipe Height: **12** (in.) Rod and Bar (Angled)
Pipe Material: **Clay** ☐ Pipe Lined
Invert Depth: **10.41** (ft.) Flow Characteristics: **Slow**
Deposits: ☒ None ☐ Mud ☐ Sludge ☐ Debris ☐ Grease
Silt Depth: (in.) Deposits Extent:
Infiltration: **None** Pipe Seal Cond: **Sound**
